Technical Bulletin

01 07 69 Dec. 13, 2007 2016182 Supersedes T.B. Group 01 number 07-64 dated Oct. 1, 2007 due to corrected part number in Required Parts and Tools field.

MIL ON, DTC P129F and or P310B Stored in ECM Fault Memory

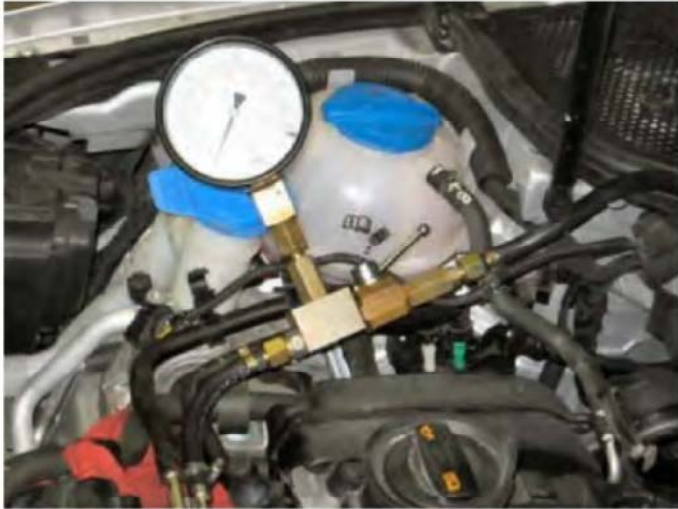
Figure 1

To verify low side fuel pressure, a mechanical fuel pressure gauge may be connected in the engine compartment (figure 1).

- Add 1 bar (14.5 psi) to value obtained from mechanical gauge to calculate adjusted gauge measurement.
- Compare adjusted gauge measurement to value stored in MVB 103 field 1.

VAG 1318 gauge installed on a 2.0T FSI vehicle.

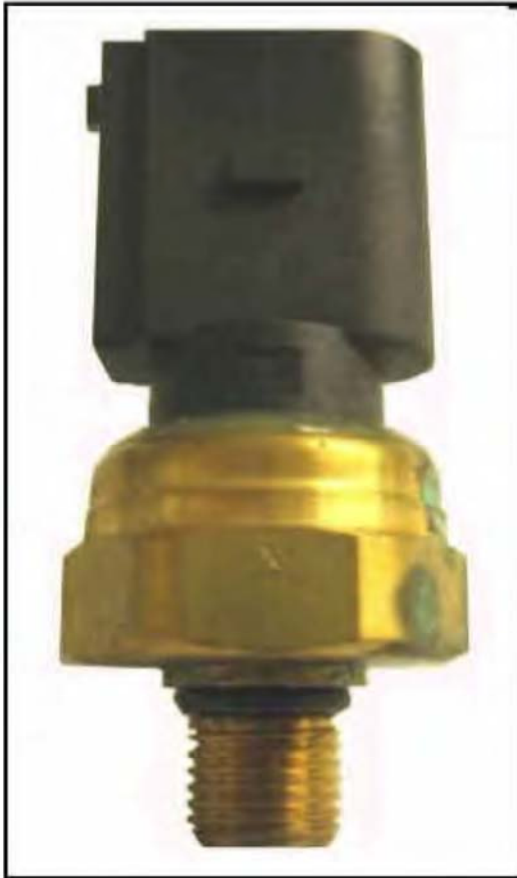
Figure 2

2.0L (BPY) Fuel pressure sensor

Part No. 06E 906 051 J.

3.6L (BLV, BHK) Fuel pressure sensor

Part No. 03C 906 051A.
