Technical Service Bulletin

MIL on (DTC P2293 in ECM)

15 07 02 June 18, 2007 2013147/4. Supersedes Technical Service Bulletin Group 21 number 06-04 dated Dec. 11, 2006 due to addition of description of one of the main conditions that can result in the storage of P2293.

Model(s)	Year	VIN Range	Vehicle-Specific Equipment
A3	2006 – 2007	All	2.0TFSI Engine
A4	2005 – 2007	All	
A4 Cabriolet	2007	All

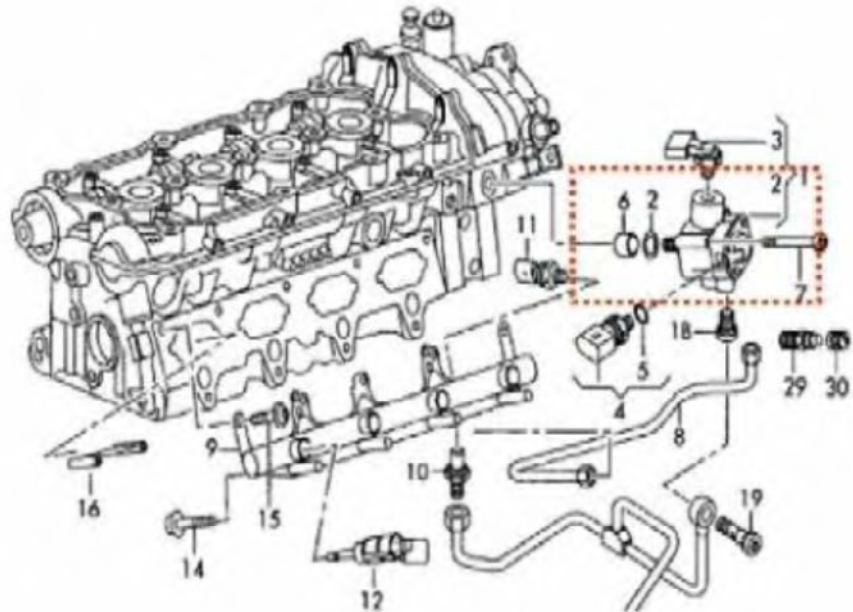
1. Remove the high pressure fuel pump and visually inspect:
 - The base surface of the cam follower (Figure 1, Point 6) in contact with the camshaft lobe.
 - The tip of the high pressure fuel pump plunger.
 - The high pressure fuel pump camshaft lobe.

Figure 1. The high pressure fuel pump.

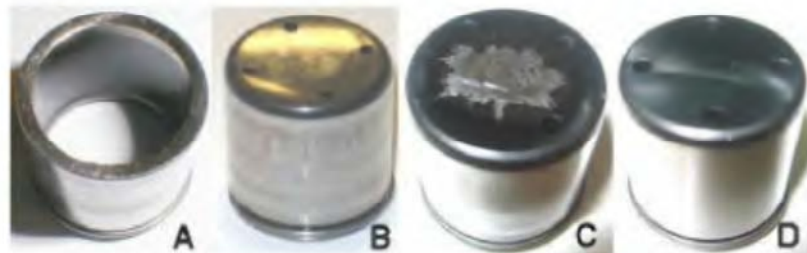
2. If the base of the cam follower looks like Figure 2, C or Figure 2, D, no excessive wear is present. The cam follower and camshaft should not be replaced.

Figure 2. Cam followers in various stages of wear: holed base (A), excessive wear (B), normal wear (C), and new part (D).

3. If the cam follower base surface is excessively worn so that its surface is concave (Figure 2, B) or altogether missing (Figure 2, A), or if the high pressure fuel pump camshaft lobe shows excessive wear (Figure 3), replace the intake camshaft and the cam follower.

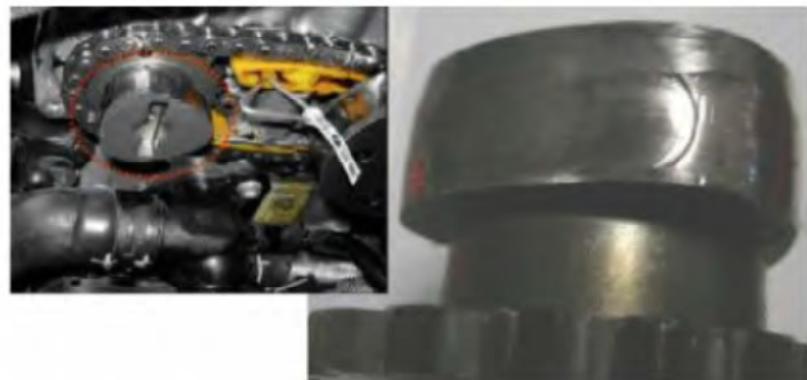
Excessive wear of the cam lobe (in the intake camshaft) that drives the high pressure fuel pump. This limits the maximum pump piston lift, causing fuel rail pressure fluctuations. The wear on the cam lobe also leads to wear in the base of the high pressure fuel pump cam follower.

Figure 3. Excessive wear on the lobe for high pressure fuel pump in the intake camshaft.

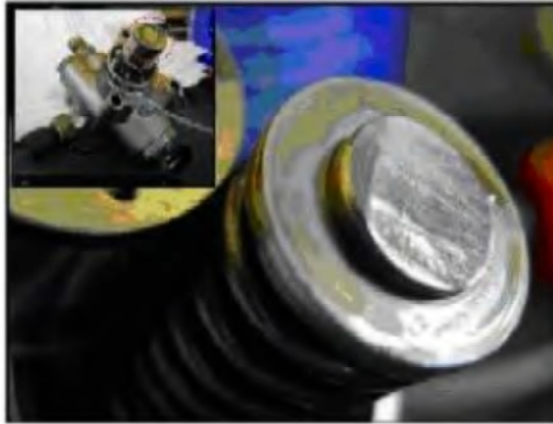
Figure 4. Excessive wear marks on the tip of the high pressure fuel pump plunger.

4. The high pressure fuel pump must be replaced only if the tip of the plunger shows excessive wear (Figure 4). This condition is only possible if the cam follower base is holed and the plunger tip has come in direct contact with the camshaft lobe.
5. If no excessive wear can be found in the high pressure fuel pump cam follower or intake camshaft lobe, or if the damage is found in camshafts with part number 06F 109 101 B, please create a Technical Assistance Contact Ticket under the Concern Type Engine and Engine Electronics in ElsaWeb. Attach the complete diagnostic log to the contact, and call the Audi Technical Assistance Center (Audi Helpline) for further assistance.
